## Facility & Feasibility Study

### Hill Farm Barn

Crystal Lake, Illinois

May 16, 2016

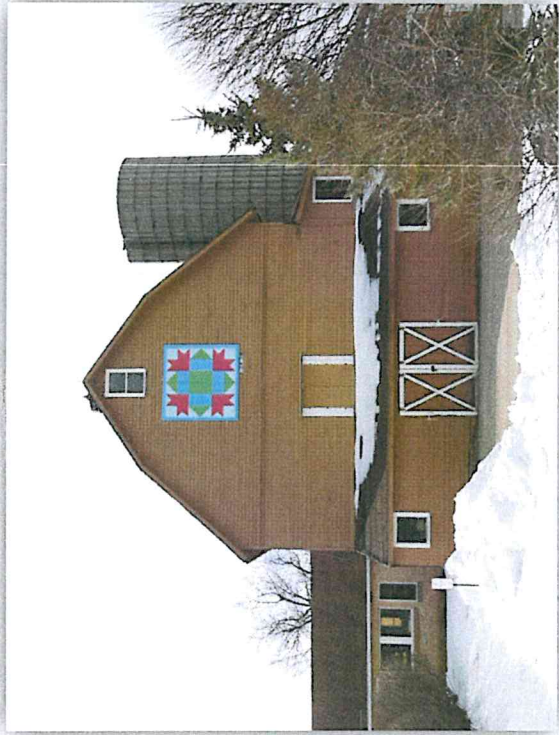
Figure 5 - Front North Elevation

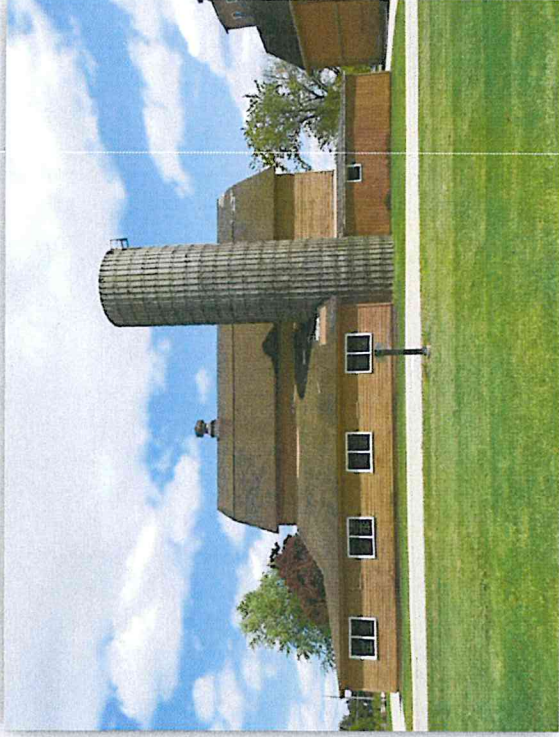
Figure 6 – West Side Elevation

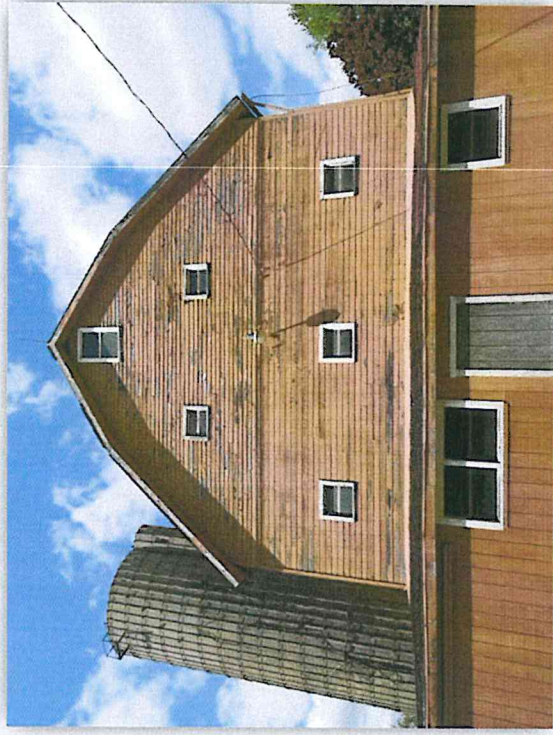
The fascia boards, especially at the South end of the barn, are in very bad shape and need to be replaced.

Figure 7 – Rear South Elevation

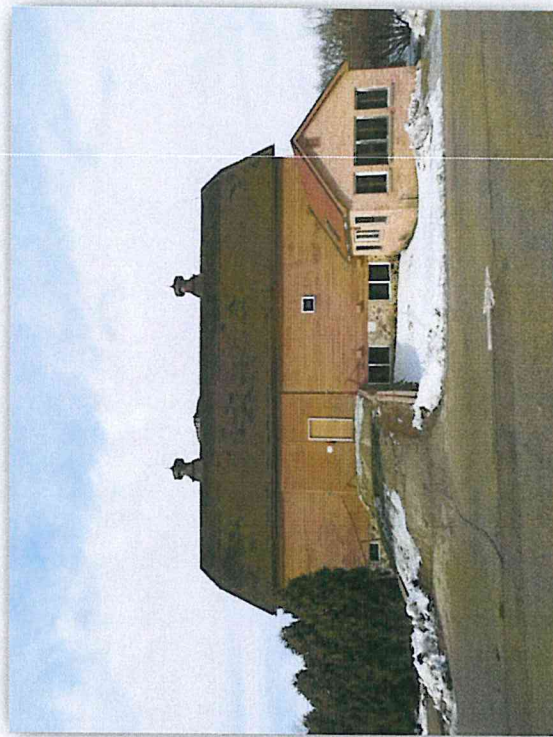
Figure 8 – East Side Elevation

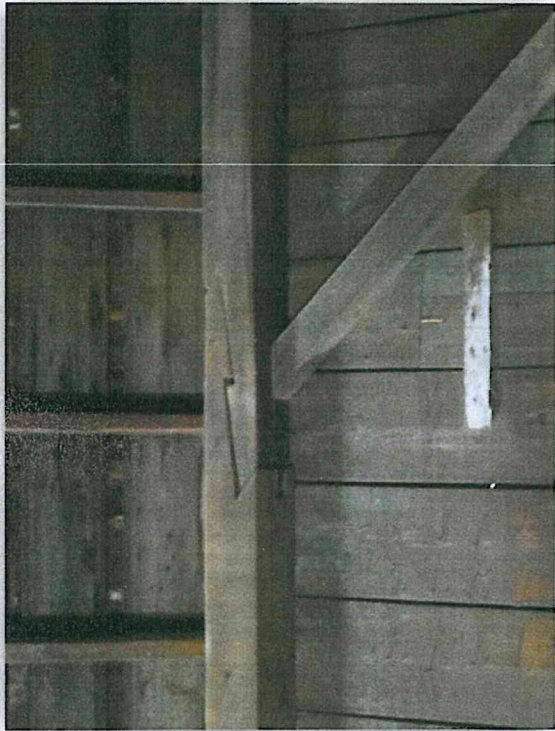
Figure 13 - Scarf Joint at Top Plate

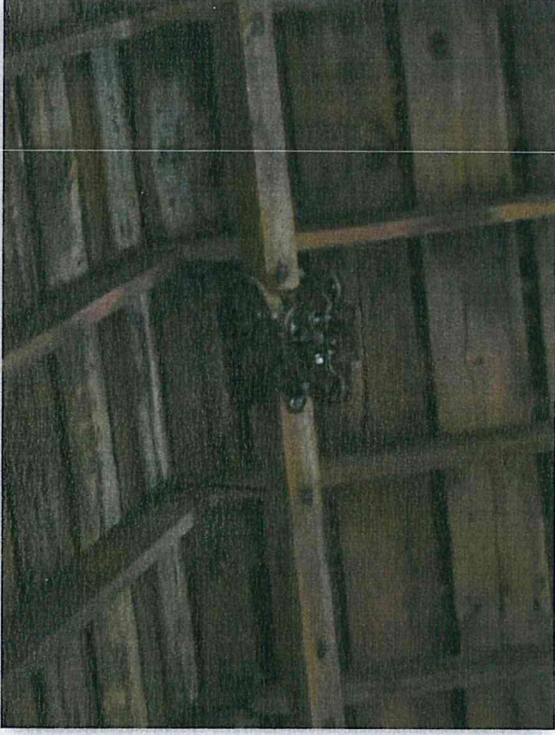
Figure 18 – Hay Fork Trolley on Wood Rail Beam

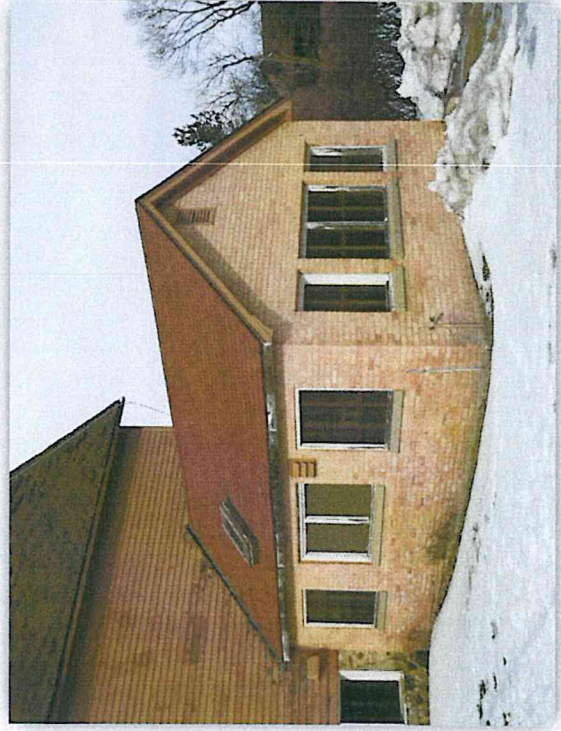
A brick Milk House exists at the northeast corner of the original barn. The brick is still in very good condition as are the mortar joints. The windows are in need of some attention and possible replacement. The fascias are in poor condition and should also be replaced. The interior walls of the milk house were done in plaster.

Figure 19 – Milk House

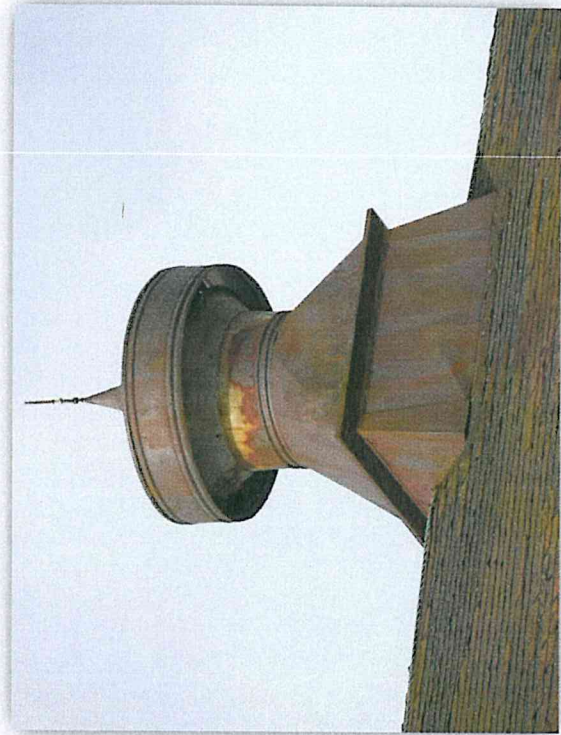
Two large ventilators at the roof were meant to keep the air moving through the barn. These ventilators are still in very good condition for their age and do not exhibit the usual buckshot holes that many barn owners inflict on this equipment. These ventilators could be removed, re-galvanized, and re-installed as part of a roof replacement and they would look like new. Typically barns were built to breathe and air flowed through the barn and out the ventilators at the roof. Since the second layer of siding was added the air flow through the outside walls has been reduced. Consequently the barn doesn't breathe the way it was intended to and consequently retains moisture longer.

Figure 20 – Roof Ventilator

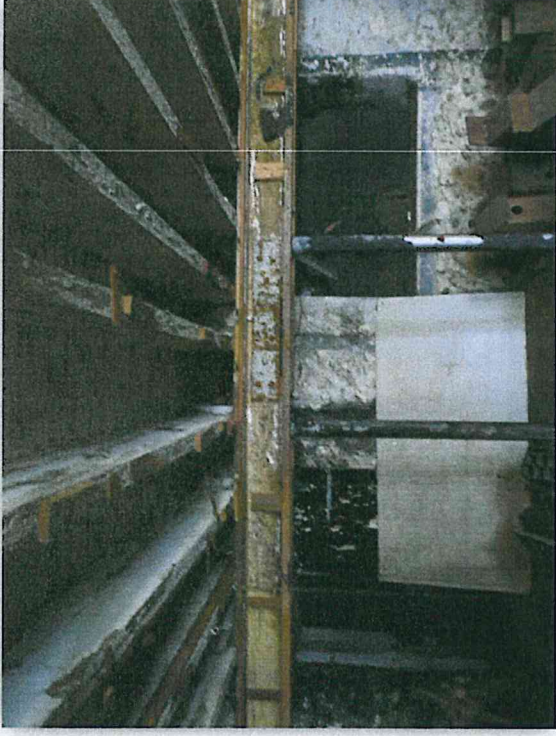
The barn is supported at the lower level milking parlor by 20" thick stone foundation walls at the East and West outside walls of the barn. A sill beam sits on top of the foundation walls and supports the upper outer wall posts of the timber frame structure above. Internal steel columns support the main wood beams that run the length of the barn. The main beams support true 3x12 floor joists that support the mow floor above.

Figure 22 – Structure Supporting Mow Floor

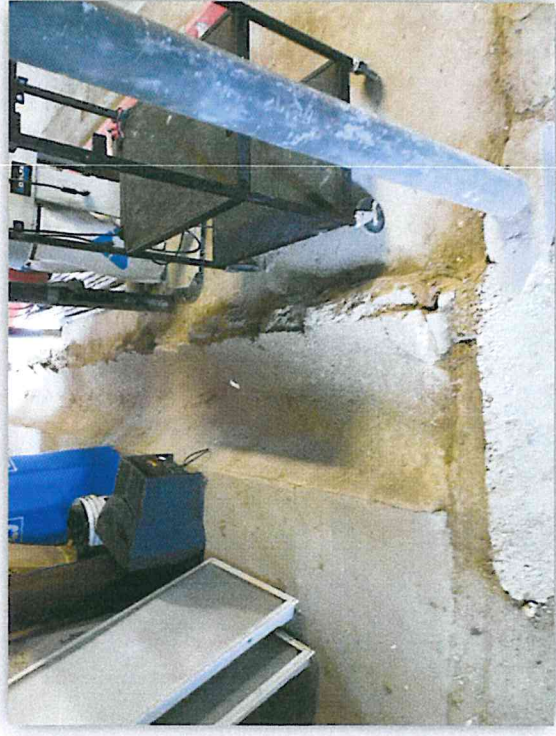
Since the barn was converted for dairy operations there are troughs and curbs in the concrete slab at the milking parlor. As is typical the concrete floor is quite uneven and rough and has been patched in numerous areas.

Figure 23 – Troughs in Concrete Floor

10. Some type of roofing will be necessary. Determine the future use of the barn and proceed to address the roof accordingly.
11. Close up the lower level end walls with framed walls and large doors.
12. Level lower level floor to make it more usable.

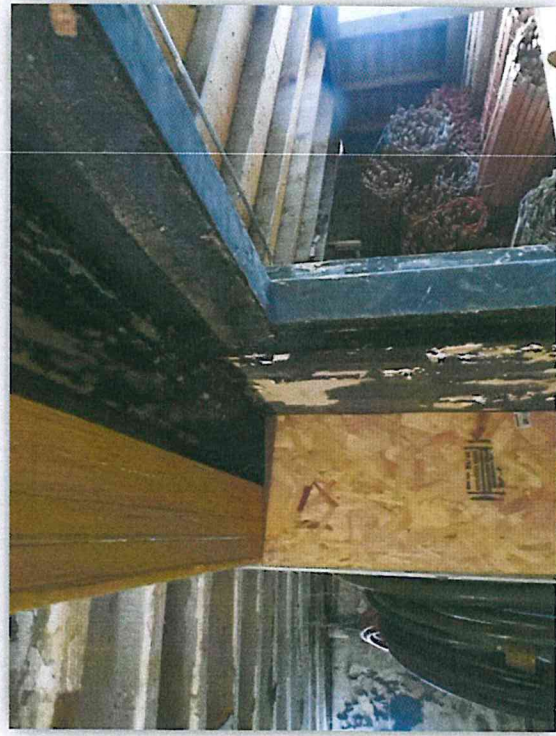
barn siding and structure and has caused significant rot of the sill plate. Since the entire main barn structure bears on the sill plate this is a significant issue. The lean-to additions on the South and Southwest corner were also constructed with T-11 siding which is inexpensive and doesn't last very long. The lean-to additions have numerous holes in their roofs, damaged fascia boards, and the siding has significant rot and decay. These additions should be removed as soon as possible as they are causing further damage to the original barn. The rafters and posts should be salvaged as there is a significant amount of lumber there.

Figure 24 – Attempt to Repair Sill Beam/Header at Door

4. Remove the structure that connects the barn to the silo as it will need to be rebuilt correctly.
5. Jack the barn structure off of the sill beam and replace all damaged sill beams. Fixing the structural issues up front is always the best course of action. Since you are jacking the barn to fix the sill beams this is an opportune time to repair the foundation.

6. Set timber structure back down on new sill beam.
7. Plumb and straighten the timber structure as required.
8. I would recommend removing all horizontal siding and restoring barn back to its original glory with vertical board and batten siding.
