## Facility & Feasibility Study

### Hill Farm Barn

Crystal Lake, Illinois

May 16, 2016

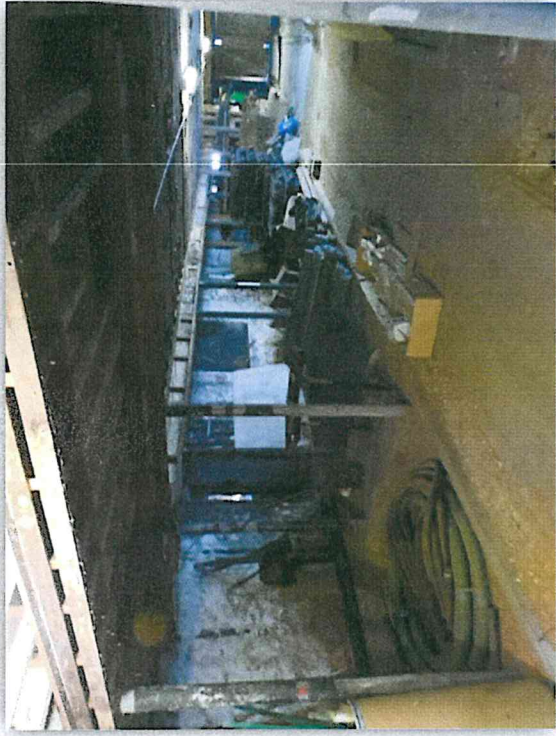
Figure 21 – Ground Level Milking Parlor

The barn is supported at the lower level milking parlor by 20" thick stone foundation walls at the East and West outside walls of the barn. A sill beam sits on top of the foundation walls and supports the upper outer wall posts of the timber frame structure above. Internal steel columns support the main wood beams that run the length of the barn. The main beams support true 3x12 floor joists that support the mow floor above.
